TANK BOTTOM PLATE INSPECTION & CORROSION MAPPING

Inspecta International uses the *Floormap VS2i*, a computerised magnetic flux leakage system designed to detect, size and map underfloor corrosion on above ground storage tanks.

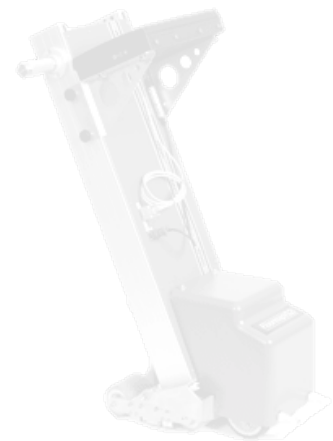
- High grade magnets to improve corrosion detection,
- Accuracy to within 3mm on 8 metre length,
- Maximum thickness of 12 – 20 mm (depending on mode)
- Combined defect profiling & amplitude analysis.
- Real time data acquisition,
- Automatic CAD Drawing
- Ability to add data from VT, UT, MT, Vac box.

1. Powerful magnets are used to generate magnetic fields in the test material.
2. Where there is a discontinuity, the field “leaks” from the plate, and is detected by a sensor in between the poles.
3. The leaks are then used to characterize any defects.
4. The motorized *Floormap VS2i* moves along the surface at 0.5m/sec creating a corrosion map.
